ANNUAL EXPERIMENTAL EVALUATION REPORT

Cold In-Place Recycle (CIR) Koch™ Process CIR-EE

Location: Red Lodge, Montana – Carbon County, Highway 212 (P-28) Milepost 91-101.6

Project No.: Red Lodge North STPP 28-2(22)70

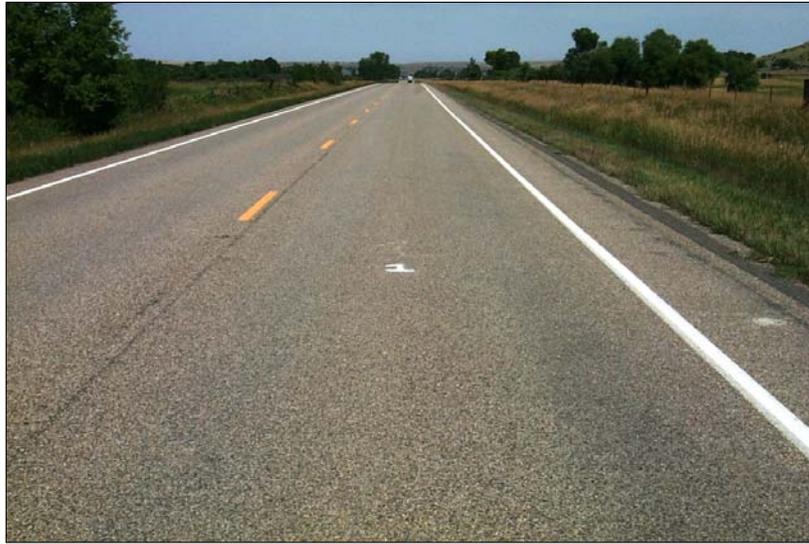
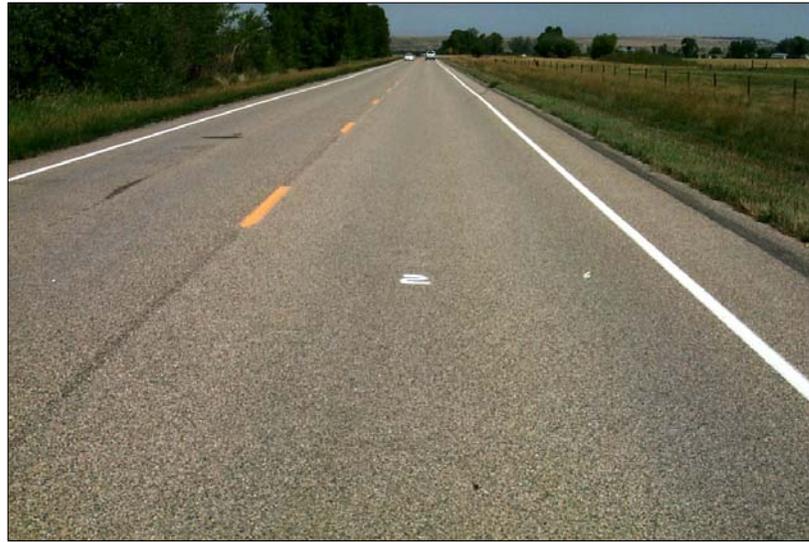
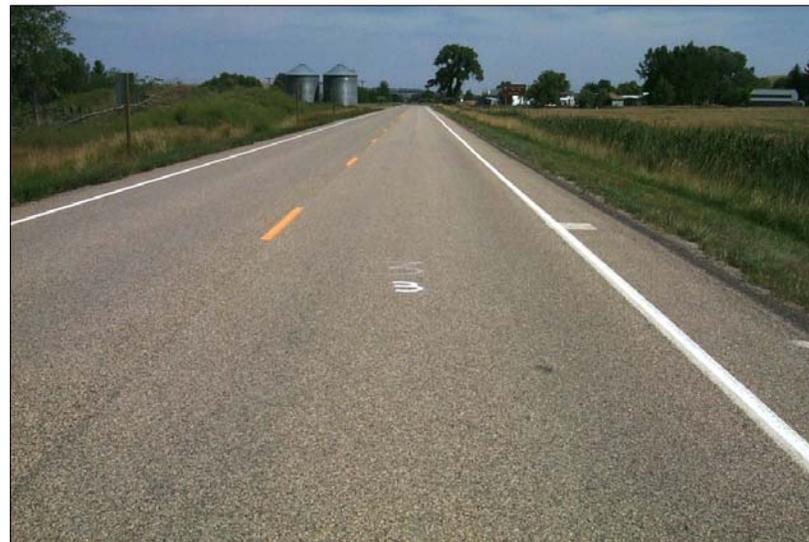
Data sites 1, 2, & 3

To date sections 1 and 6 have no noticeable cracking. Sections 2, 3, & 4 are beginning to show progressive transverse cracking, all low severity in nature. At this time the extent of transverse cracking in all sections is minimum and rated as good to fair.

Section 1: MP 89- MP 91, 90mm cold mill, 105mm PMS

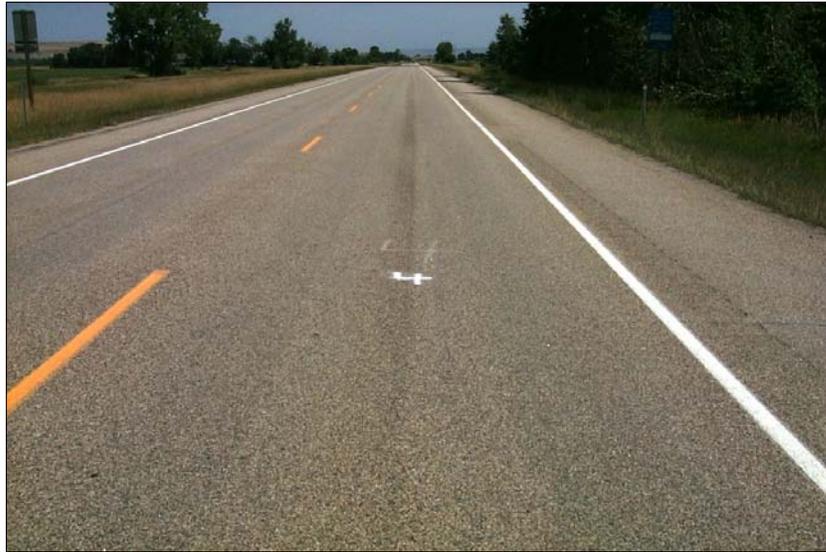
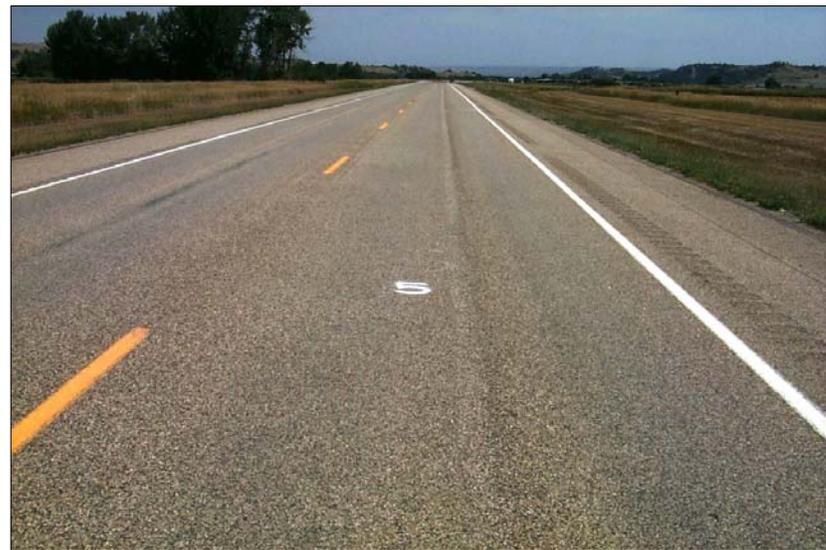
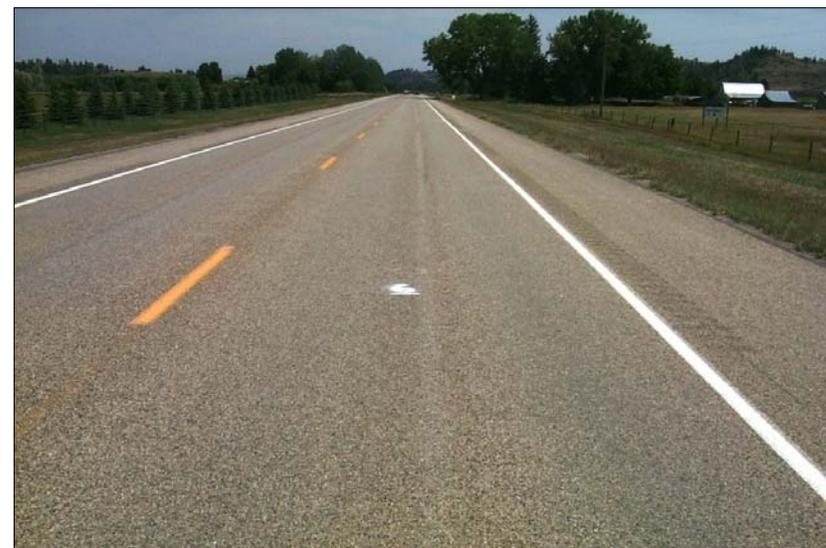
Data sites 4, 5, & 6

Most data sites exhibited good appearance and even seal with minimum rut. Several sections did have minimum flushing mainly in the wheelpaths. Section 2 (75mm recycle, 45mm PMS) displayed the best performance in rutting. Both 75mm recycle sections (3 & 5) exhibited the most in averaged increased rut. On average rutting is minor on the entire project.

Section 2: MP 91-MP 94.3, 75mm recycle with 45mm PMS overlay

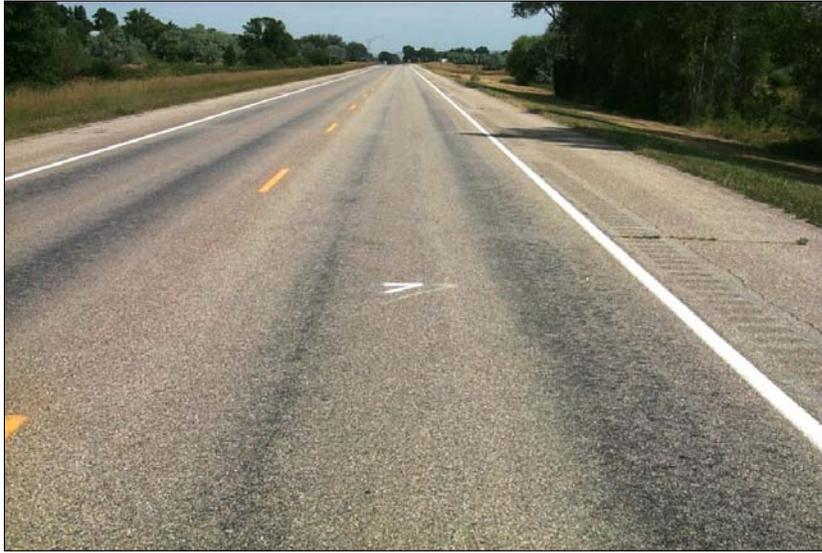
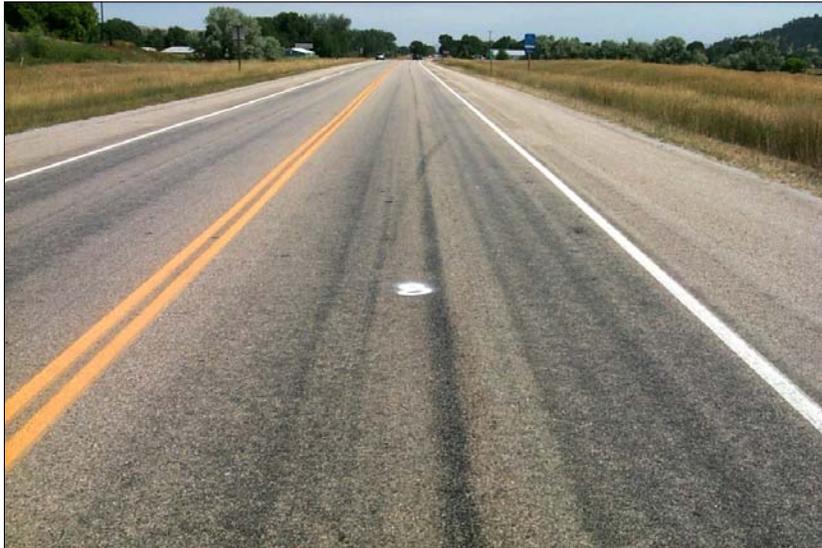
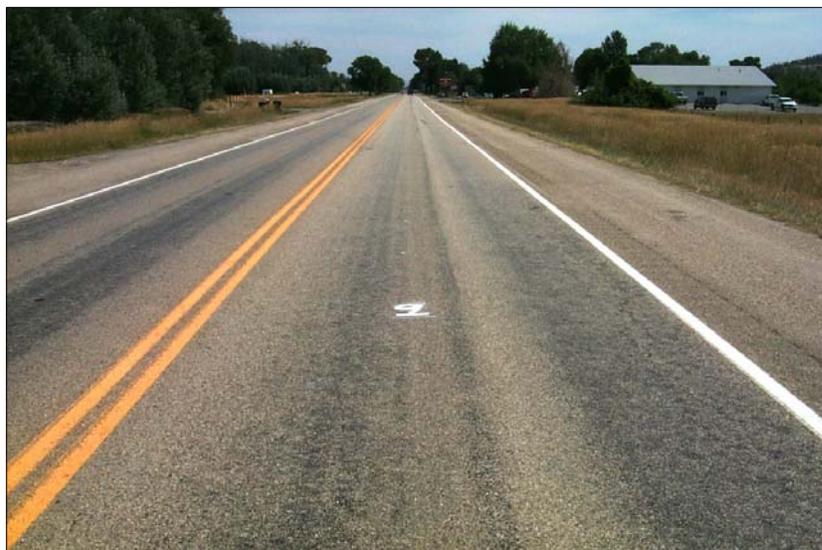
Data sites 7, 8, & 9

Section 3: MP 94.3-MP 95.4, 75mm recycle with seal and cover

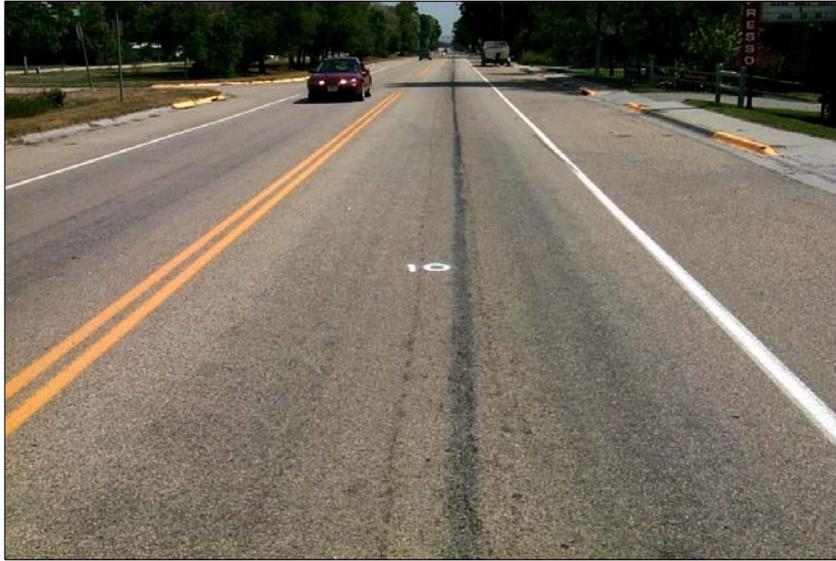
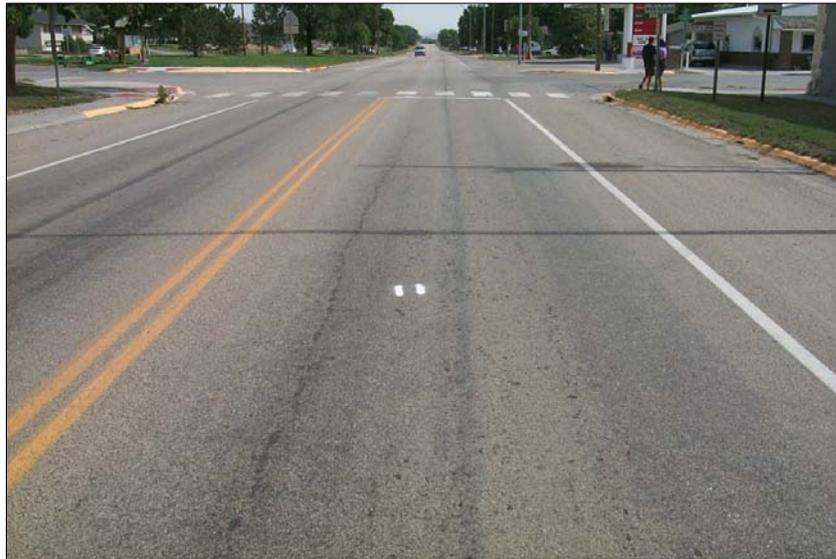
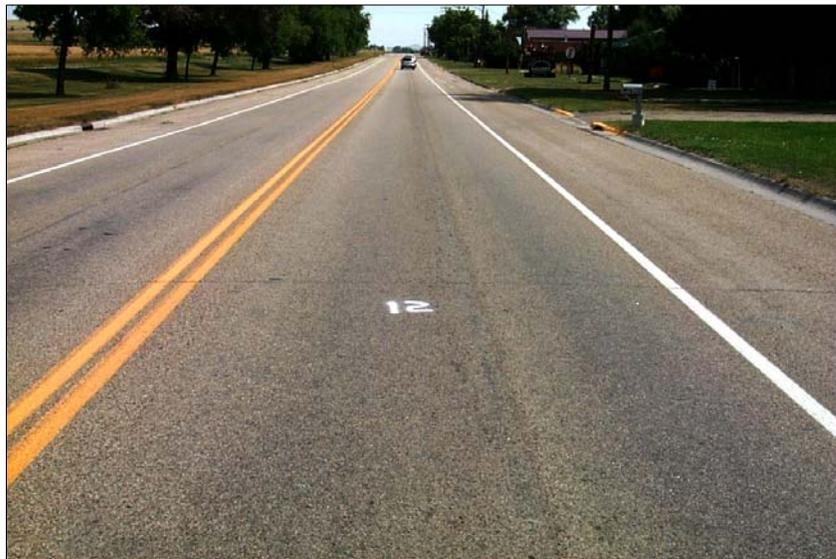
Data sites 10, 11, & 12

Section 4: MP 95.4-MP 96.3, 75mm mill and fill PMS

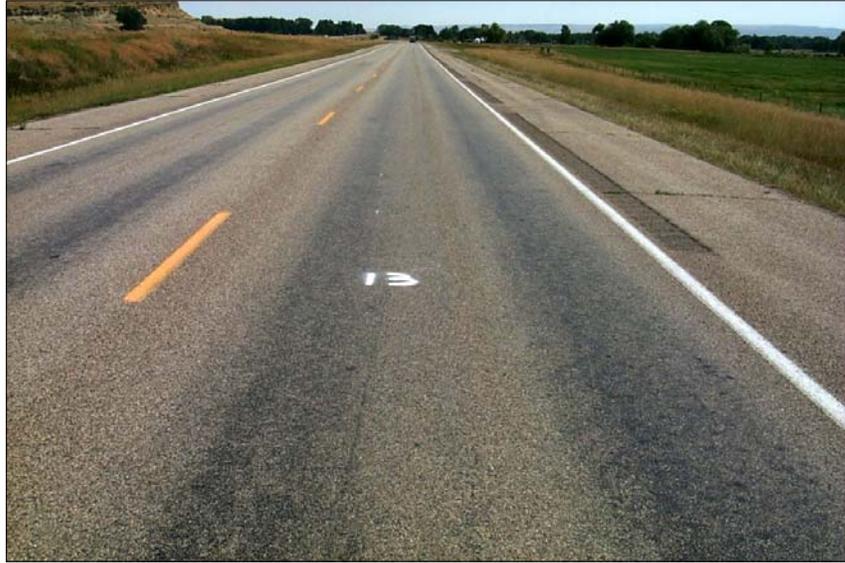
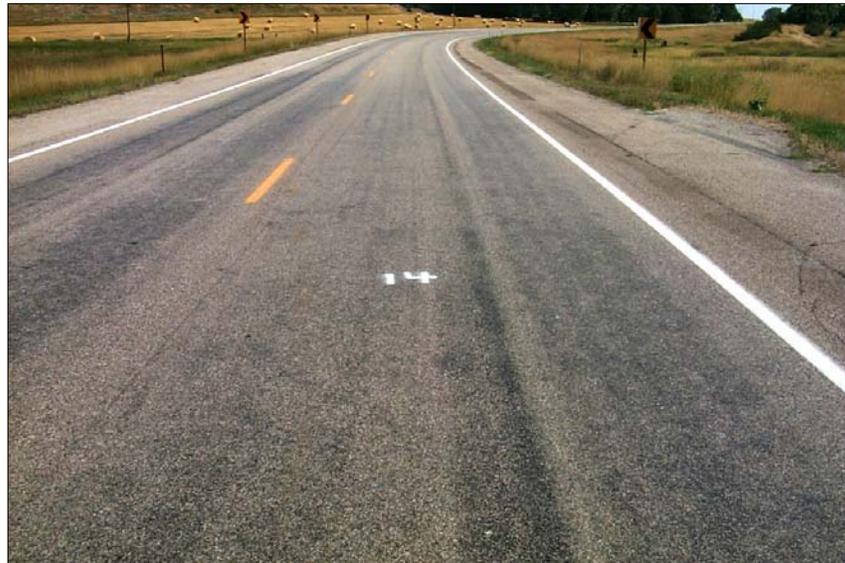
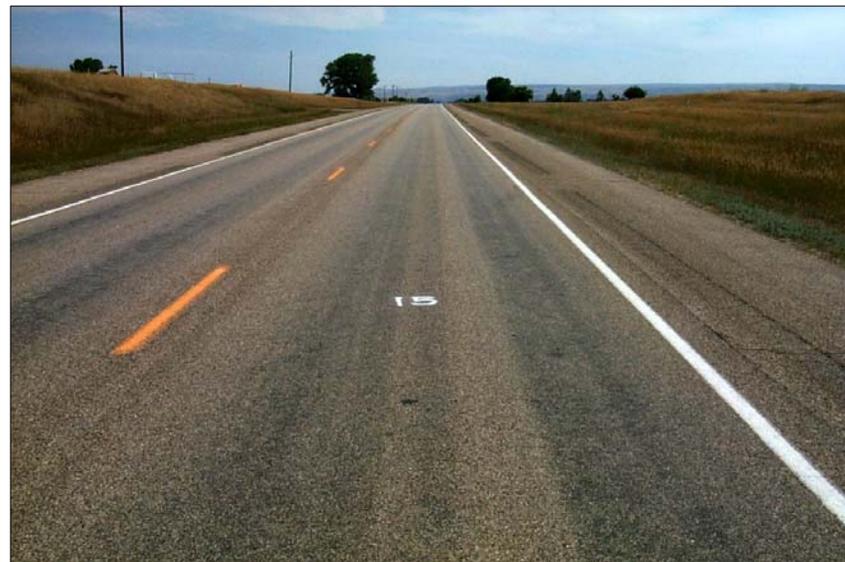
Data sites 13, 14, & 15

*This data site was located in section 5, milepost 97.5 at the 75mm recycle site. The extrapolation puts the CPM at 140, with a standard deviation of 2. This report will note that initially with the first annual inspection, there was an abnormally high transverse cracking within the 300' data site. To date, a total of nine, low severity transverse cracks have been documented. The other two data sites within this section are beginning to exhibit across-lane cracking. In earlier analysis it was speculated data site 97.5 was anomalous with cracking compared to the entire section. However, with the increased cracking within the other two data sites may be an indicator of performance.

Section 5: MP 96.3-MP 98, 75mm recycle with seal and cover

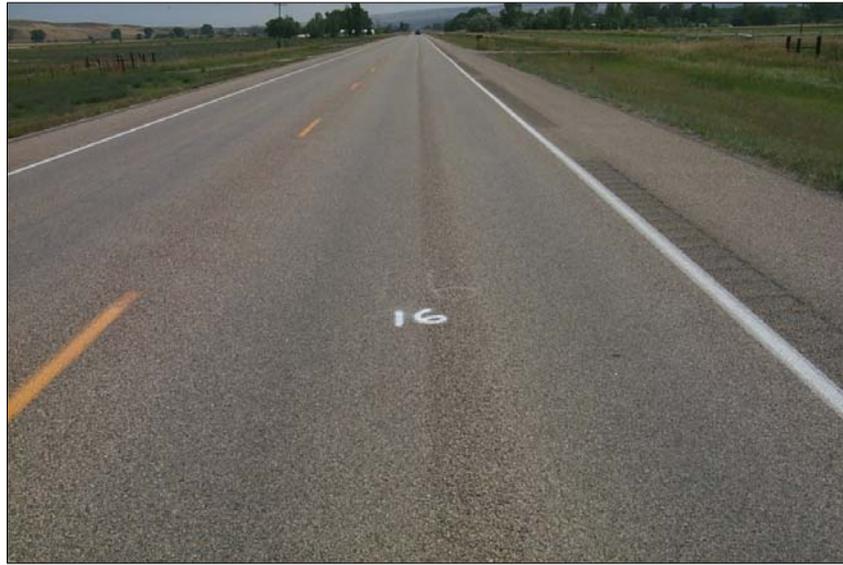
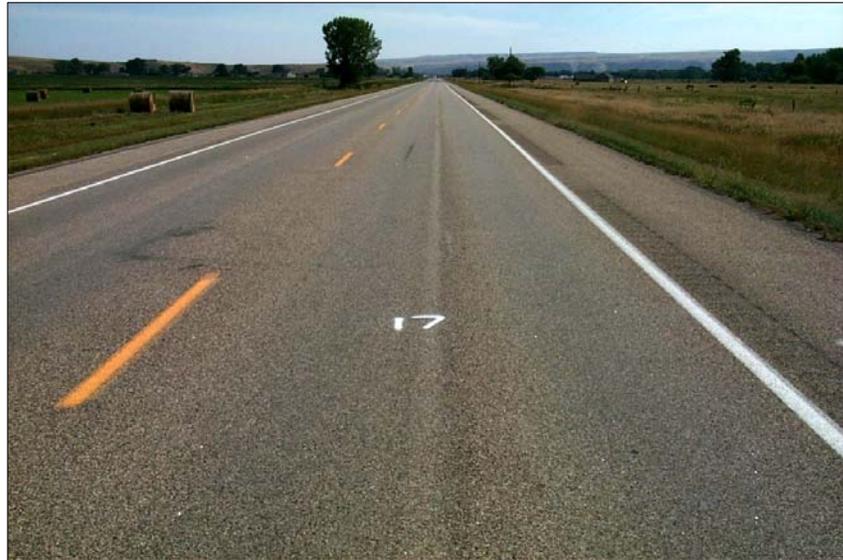
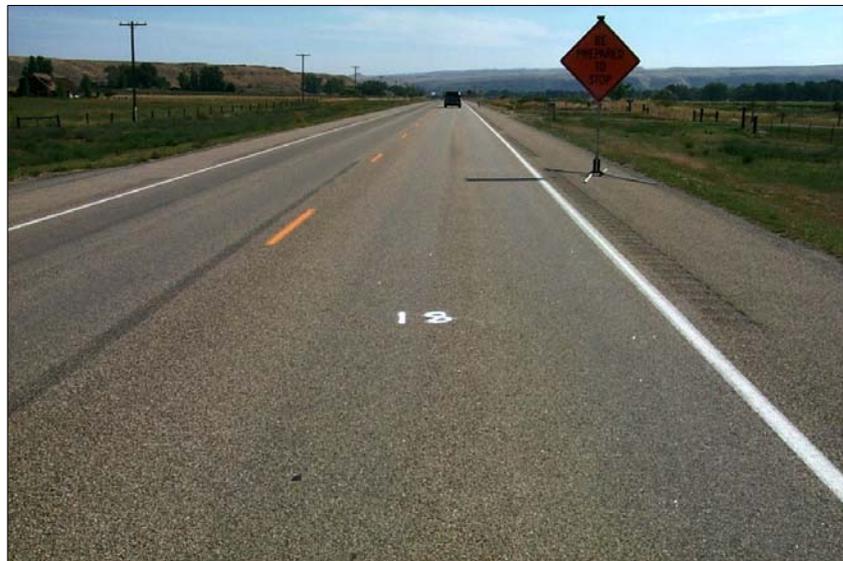
Data sites 16, 17 & 18.

Section 6: MP 98-MP 101.6, 75mm recycle with two lifts of PMS (90mm)
